PROJECT INFORMATION SHEET

Project Title 223 Anderby Creek
Client Environment Agency
Value £125,000
Start Date 14 October 2013
Finish Date 18 October 2013
Contract UX85469/2025
Site Agent Lee Long & Stuart Robinson
Suppliers G Nicholson Engineering Ltd

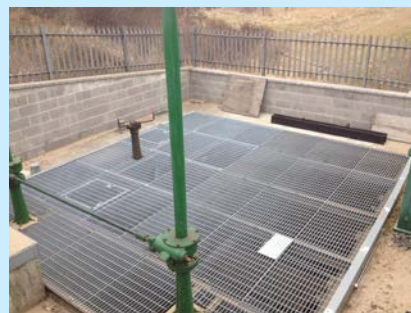
Photo 2: Surface level of chamber containing the flap valve.

The project involved renewing the flap valve like-for-like and replacing the hinges which had become worn over time.

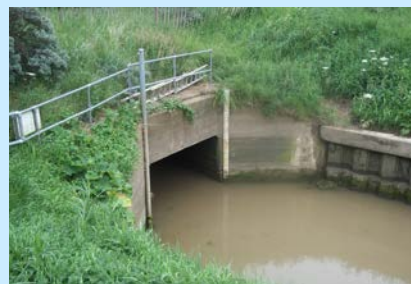
Photo 3: Outfall of Main Drain in to the chamber. The flap valve prevents the incoming tide from entering the drain.
